Subject: March 30-31, 2022 SPCC Inspection Report for R+L Carriers, Inc. Wilmington Service Center (WIL Terminal); Facility ID: R5-OH-00474

Photo Log for EPA SPCC Inspection at R+L Carriers Facility on 03/30/2022 Photos taken by OSC Renninger, OSC/SPCC Inspector with US EPA Camera: iPhone 11

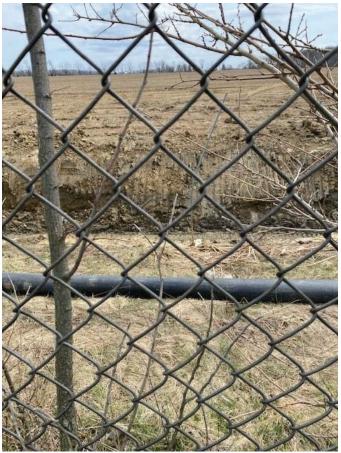
Description: Tank #27 catch basin (foreground) with subsurface perforated pipe (background) inside secondary containment. Note automatic pump in catch basin was routed to frac tanks on March 8, 2022 following spill (gray pipe). Prior to March 8, 2022, automatic pump discharge was to Dutch Creek approximately 100'east of catch basin outside of secondary containment.

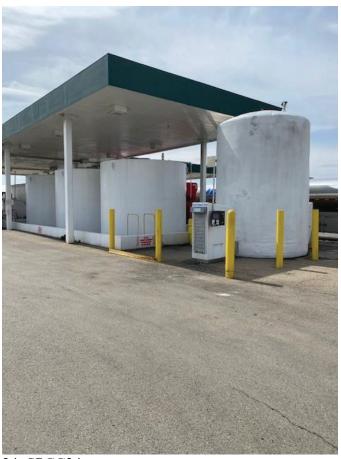
Description: Fueling Island Tank #23 secondary containment with visible staining on containment wall. Note hole in containment wall where staining appears to originate was observed to have an open pipe connecting the containment for Tank #22 to the containment for Tank #23.

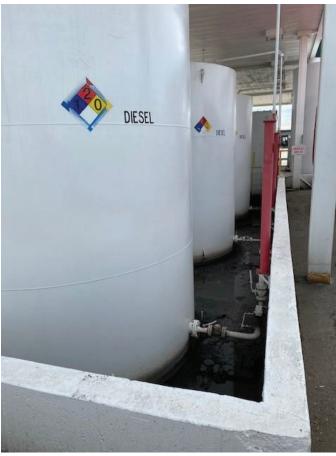
Description: Outside Fueling Island Tank #23 (three, 20,000-gal diesel tanks) in secondary

containment; note staining on pavement.

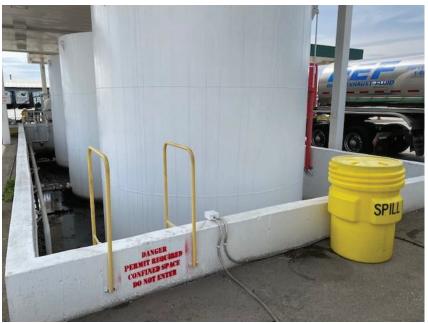
Description: Fueling Island Tank #23 (three, 20,000-gal diesel tanks) in secondary containment.

Note containment observed to be filled with a mixture of sludge, oil, and water.

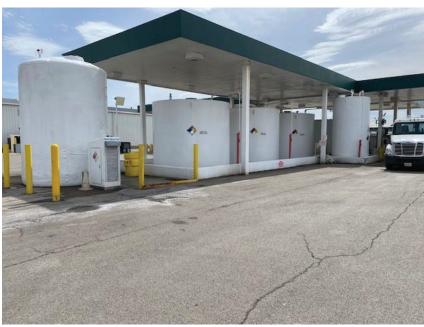
Description: Fueling Island Tank #23 (three, 20,000-gal diesel tanks) in secondary containment and adjacent spill kit. Note visible staning on tanks; containment observed to be filled with a

mixture of sludge, oil, and water.

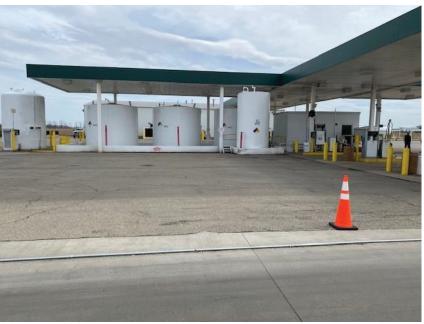
Description: Fueling Island Tank #23 secondary containment and sump pump. Note: containment observed to be filled with a mixture of sludge, oil, and water, and sump pump was observed to be running.

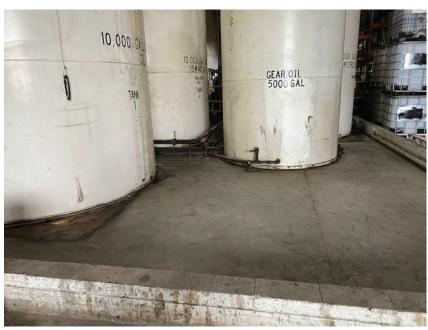
Description: Maintenance Building Oil Storage Room Tanks #12, 13, and 14 inside secondary containment. Building also contains mobile/portable containers. Note staining on tanks and

outside containment wall.

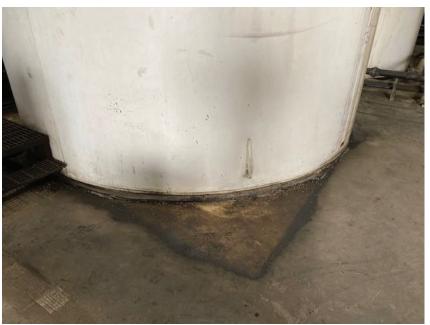
Description: Maintenance Building Oil Storage Room transfer hoses and secondary containment.

Note staining on containment walls and floor and visible absorbent pads on floor.

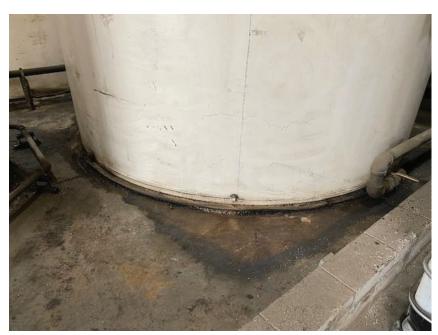
Description: Maintenance Building Oil Storage Room secondary containment. Note staining and

oil-dri material around bottom tank.

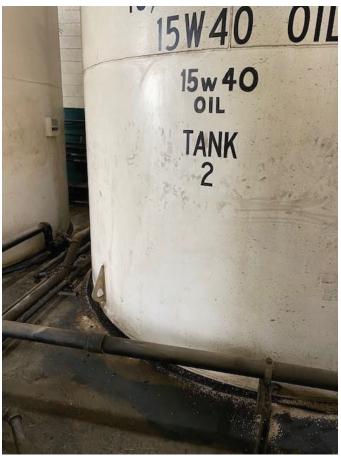
Description: Maintenance Building Oil Storage Room Tank # 14 (per SPCC Plan). Note staining

and oil-dri material in secondary containment; staining on top of piping.

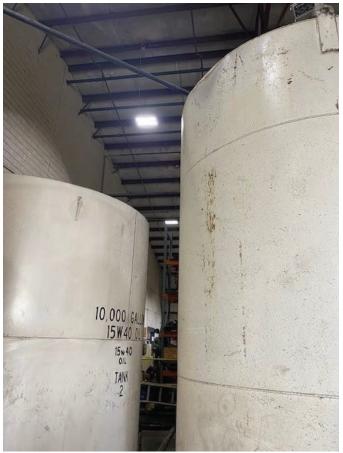
Description: Maintenance Building Oil Storage Room Tank # 14 (left) and 12 (right). Note dent

at top of Tank #12; visible staining on tanks.

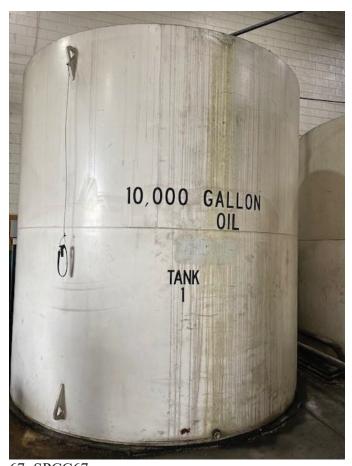
67: SPCC67 Time of Photo Taken: 1546 hours Compass Direction: North

Description: Maintenance Building Oil Storage Room, Tank # 13 (per SPCC Plan). Note visible

staining on tank; visible coating failure and corrosion near bottom of tank.

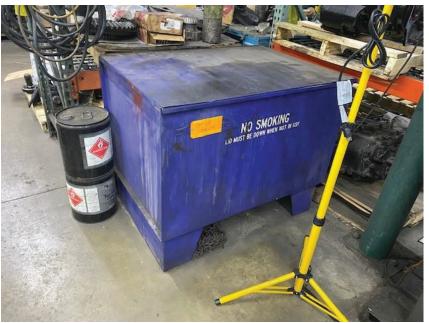
Description: Maintenance Building Transmission Room parts washer. Note this is labeled as

"Out of Service" but facility personnel indicated that it is In Service.

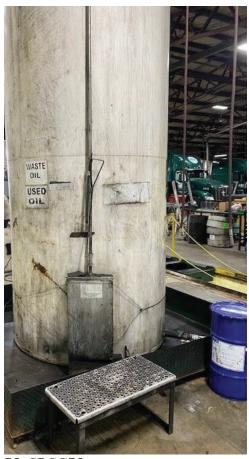
75: SPCC75

Description: Photo has been altered from original in order to remove visible employees. Maintenance Building Tank # 2 with secondary containment. Note staining on tank.

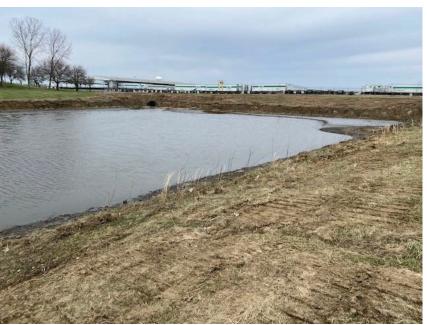
Description: Retention Pond with pipe inlet in top left. Note that walls of Retention Pond have

been excavated to remove oil staining.

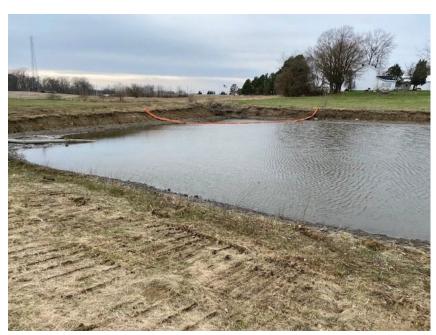
79: SPCC79

Description: Retention Pond outfall at top center with boom near outfall. Note that walls of

Retention Pond have been excavated to remove oil staining.

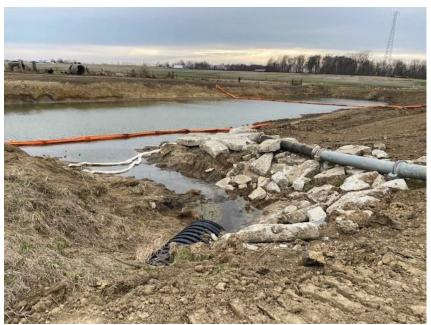
Description: Recovery Location 0.5. This oil recovery location was installed in March 2022 following spill and where the 36" subsurface pipe discharges to Dutch Creek. Note booms, sorbent, and hard booms in use. Outfall is at top right where there are three 36" pipes creating an underflow dam.

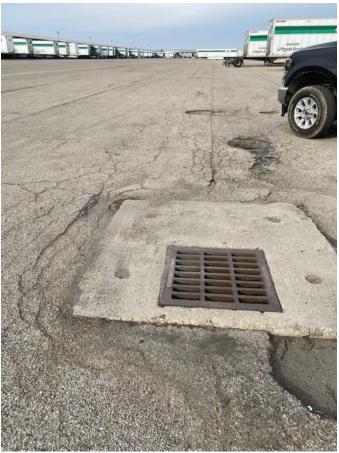
84: SPCC84 Time of Photo Taken: 1750 hours

Description: Surface drain in central area of truck parking lot. Facility personnel stated that the drain leads to the Retention Pond.
